# Car Inspection Certificate & Report

## 2023 Mercedes-Benz E300 AMG Line

VIN: WDDZF4KB9NA129841 | Plate: Dubai F-89420 | Location: AutoTrade24 Hub, Dubai

15 August 2026 • 14:30 GST

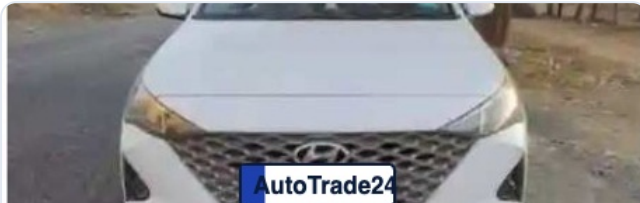
1. Front 3/4 Profile

✓ Clear

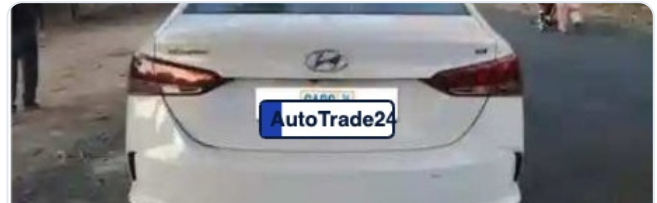
2. Rear 3/4 Profile

✓ Clear

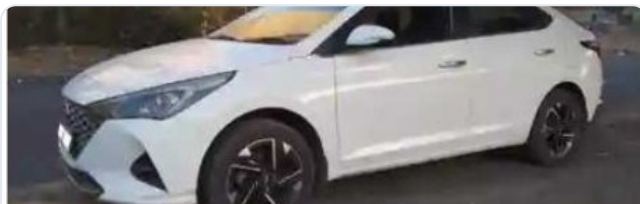
3. Full Right Side Profile

✓ Clear

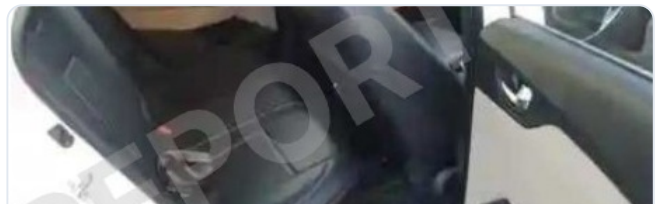
4. Driver Cabin & Door Sill

✓ Pristine

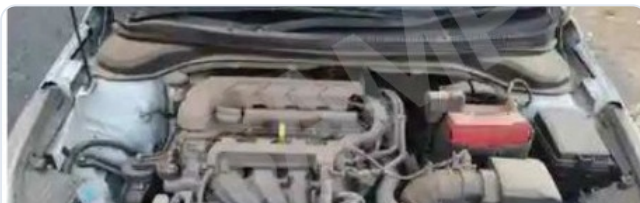
5. Engine Bay & Turbos

✓ Dry & Clean

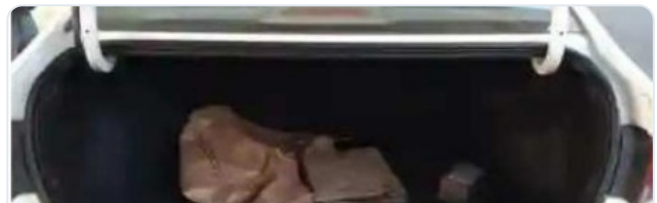
6. Trunk & Spare Wheel Bay

✓ Factory Spot Welds

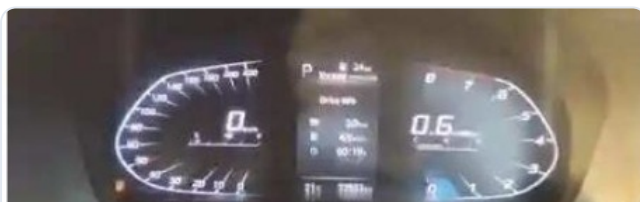
7. Digital Instrument Cluster

✓ 0 DTC Codes

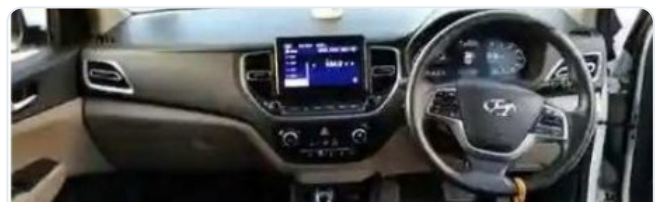
8. Center Console & MBUX Screen

✓ Fully Calibrated

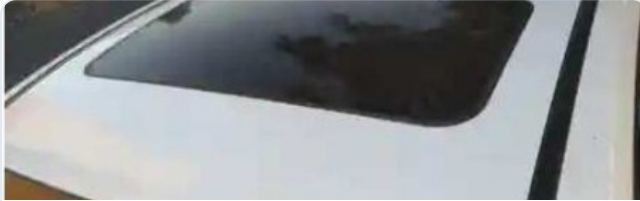
| INSPECTION PARAMETER / CHECKPOINT | STATUS | READING / NOTE |
|---|---|---|
| Roof Panel (Panoramic Dual Glass) | ! COSMETIC SCRATCH | Minor Surface Scratch |

Roof Panel: Surface Scratches

No Dents

| CATEGORY / DEFECT AREA | IMPERFECT PARTS | RECOMMENDED ACTION | EST. COST (AED) |
|---|---|---|---|
| Exterior & Body Panels | 2 | High-speed multi-stage compound polishing & detailing | AED 750 |

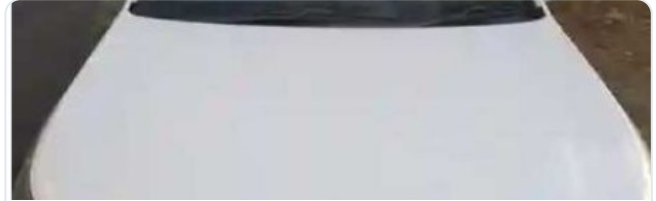
| INSPECTION PARAMETER / CHECKPOINT | STATUS | READING / NOTE |
|---|---|---|
| Bonnet / Hood Panel | ! MINOR STONE CHIP | 105 µm (OEM Paint) |

Bonnet / Hood: Micro Stone Chips

OEM Paint

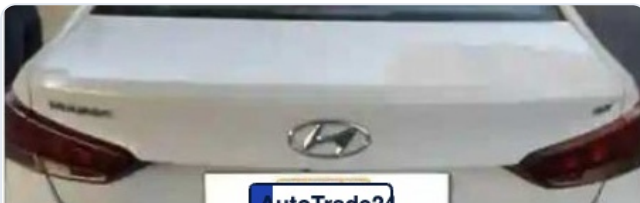
| INSPECTION PARAMETER / CHECKPOINT | STATUS | READING / NOTE |
|---|---|---|
| Boot Lid / Dicky Door | ! COSMETIC SCRATCH | 112 µm (OEM Paint) |

Dicky Door / Boot: Surface Scratch

No Dents

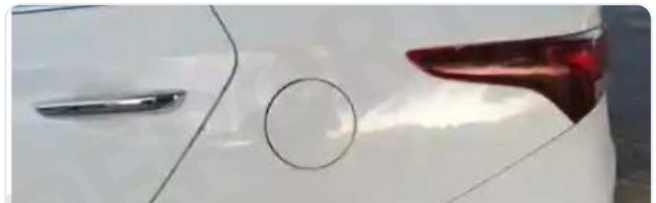
| INSPECTION PARAMETER / CHECKPOINT | STATUS | READING / NOTE |
|---|---|---|
| Quarter Panel LHS | ! COSMETIC BLEND | 180 µm (Clearcoat) |

Quarter Panel LHS: Cosmetic Repair

180 µm

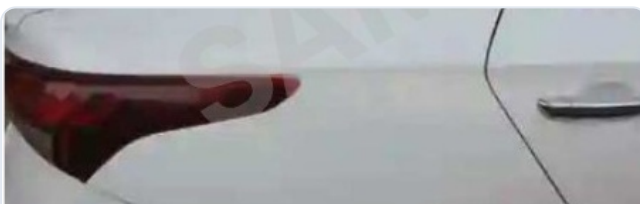
| INSPECTION PARAMETER / CHECKPOINT | STATUS | READING / NOTE |
|---|---|---|
| Quarter Panel RHS | ! COSMETIC BLEND | 185 µm (Clearcoat) |

Quarter Panel RHS: Cosmetic Repaint

185 µm

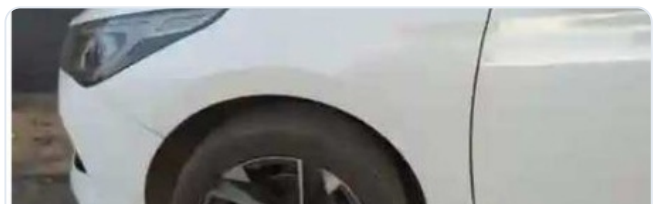
| INSPECTION PARAMETER / CHECKPOINT | STATUS | READING / NOTE |
|---|---|---|
| Fender LHS (Front Left) | ! COSMETIC BLEND | 190 µm (Clearcoat) |

Fender LHS: Cosmetic Repaint

190 µm

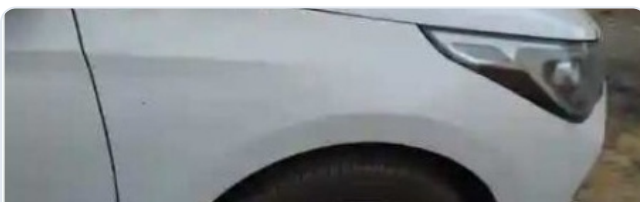
| INSPECTION PARAMETER / CHECKPOINT | STATUS | READING / NOTE |
|---|---|---|
| Fender RHS (Front Right) | ! REPAINTED CLEAR | 215 µm (Cosmetic Blend) |

Fender RHS: Repainted Clearcoat

215 µm

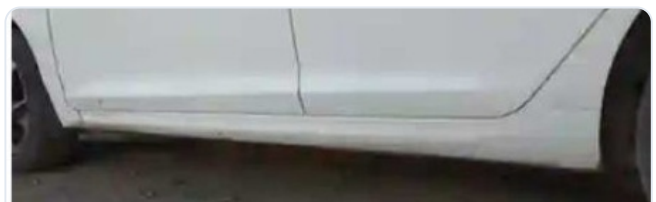
| INSPECTION PARAMETER / CHECKPOINT | STATUS | READING / NOTE |
|---|---|---|
| Running Border / Rocker Panel LHS | ! COSMETIC SCRATCH | Minor Stone Rub |

Running Border LHS: Scratched & Blended

Plastic

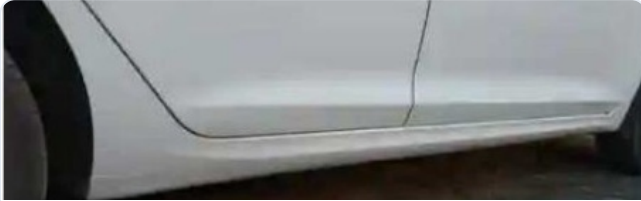
| INSPECTION PARAMETER / CHECKPOINT | STATUS | READING / NOTE |
|---|---|---|
| Running Border / Rocker Panel RHS | ! COSMETIC BLEND | Clearcoat Touchup |

Running Board RHS: Repainted

Cosmetic

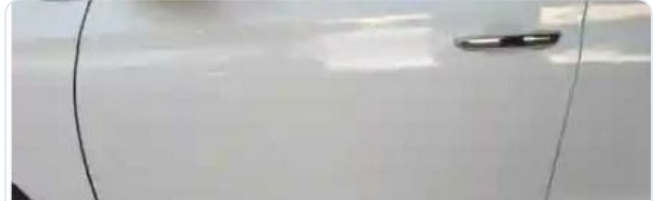
| INSPECTION PARAMETER / CHECKPOINT | STATUS | READING / NOTE |
|---|---|---|
| Door LHS Front (Driver Door) | ! COSMETIC TOUCHUP | 140 µm (OEM Base) |

Door LHS Front: Micro Scratch & Blend

140 µm

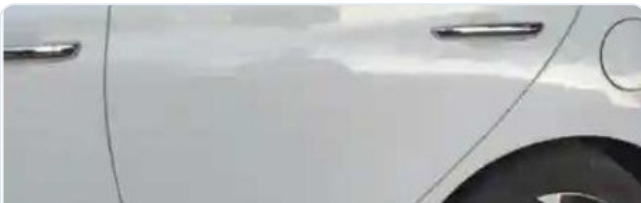
| INSPECTION PARAMETER / CHECKPOINT | STATUS | READING / NOTE |
|---|---|---|
| Door LHS Rear (Passenger Door) | ! COSMETIC TOUCHUP | 145 µm (OEM Base) |

Door LHS Rear: Repainted / Blended

145 µm

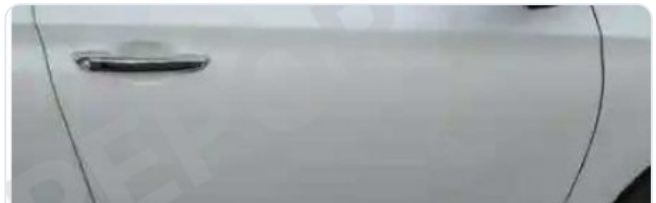
| INSPECTION PARAMETER / CHECKPOINT | STATUS | READING / NOTE |
|---|---|---|
| Door RHS Front | ! COSMETIC BLEND | 150 µm (Clearcoat) |

Door RHS Front: Repainted / Blended

150 µm

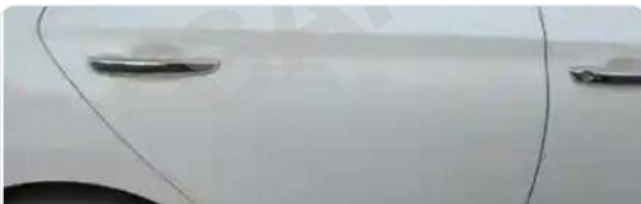
| INSPECTION PARAMETER / CHECKPOINT | STATUS | READING / NOTE |
|---|---|---|
| Door RHS Rear | ! COSMETIC BLEND | 155 µm (Clearcoat) |

Door RHS Rear: Repainted / Blended

155 µm

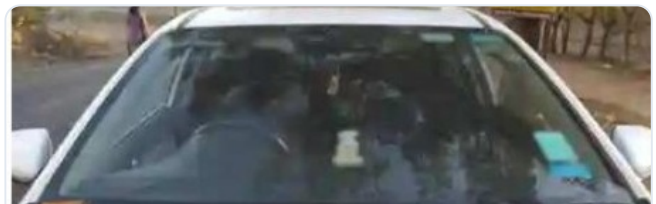
| INSPECTION PARAMETER / CHECKPOINT | STATUS | READING / NOTE |
|---|---|---|
| Front Windshield Glass | ! MICRO WIPER SCRATCH | OEM Acoustic Glass |

Windshield Front: Micro Wiper Mark

No Cracks

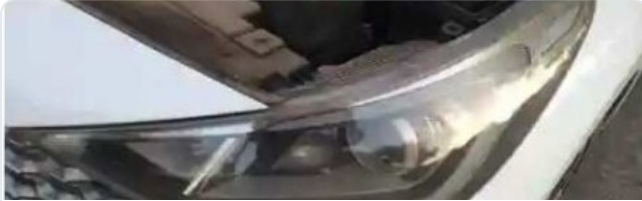
| INSPECTION PARAMETER / CHECKPOINT | STATUS | READING / NOTE |
|---|---|---|
| LED High Performance Headlight LHS | ! MICRO SCRATCH | Lens 100% Clear |

Light LHS Headlight: Scratched Lens

LED Active

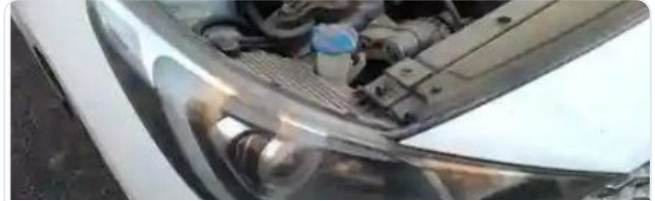
| INSPECTION PARAMETER / CHECKPOINT | STATUS | READING / NOTE |
|---|---|---|
| LED High Performance Headlight RHS | ! MICRO SCRATCH | Lens 100% Clear |

Light RHS Headlight: Scratched Lens

LED Active

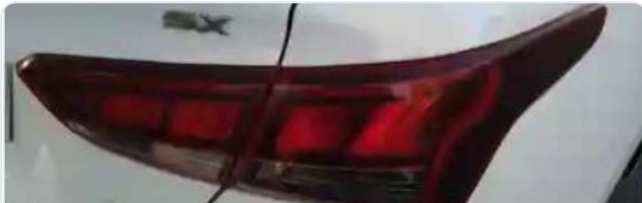
Light RHS Taillight: Micro Scratch

No Cracks

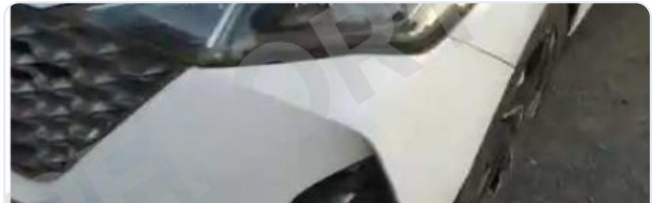
| INSPECTION PARAMETER / CHECKPOINT | STATUS | READING / NOTE |
|---|---|---|
| Front AMG Sport Bumper | ! LOWER CURB RUB | Repainted Plastic |

Bumper Front: Scratched & Repainted

Cosmetic

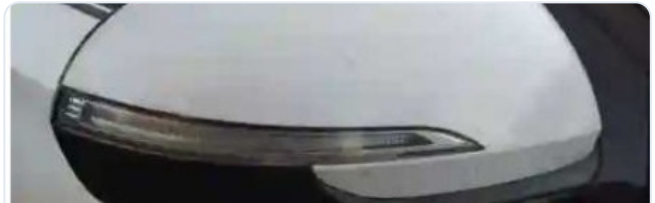
ORVM RHS: Minor Scuff on Cap

Motor Active

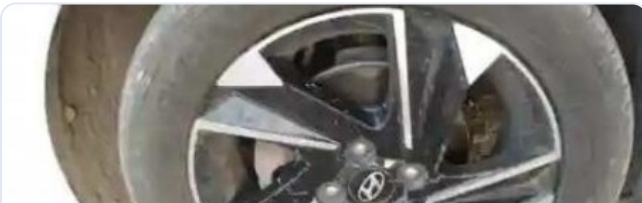
| INSPECTION PARAMETER / CHECKPOINT | STATUS | READING / NOTE |
|---|---|---|
| 19" AMG Multi-Spoke Alloy Wheels (4 Units) | ! LIGHT RIM RASH | 100% Balanced & True |

19" AMG Alloy: Light Rim Scuff

True & Balanced

| CATEGORY / DEFECT AREA | IMPERFECT PARTS | RECOMMENDED ACTION | EST. COST (AED) |
|---|---|---|---|
| Alloy Wheels & Minor Detailing | 1 | CNC Rim diamond-cut touchup for minor scuff | AED 600 |

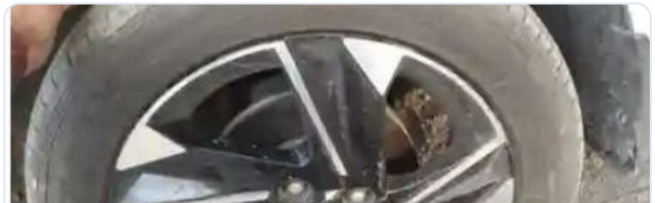
| INSPECTION PARAMETER / CHECKPOINT | STATUS | READING / NOTE |
|---|---|---|
| LHS Front Tyre (Pirelli P-Zero 245/40 R19) | ✓ 75% LIFE | 6.2 mm Tread Depth |

LHS Front Tyre: 6.2 mm Tread

75% Life
